MARINE SAFETY ALERT
Inspections and Compliance Directorate

Safety Alert 07-23

CRITICAL INSIGHT FROM ONGOING INVESTIGATIONS
INTO SMALL PASSENGER VESSEL FIRES

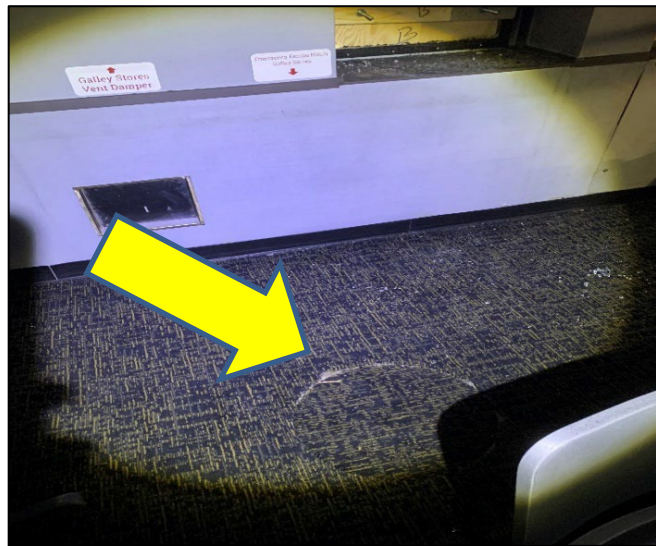
Engine Room Escape Hatch Coverings: In one of the fires, firefighters were unable to locate the engine room escape hatch on the main deck of the vessel. Evidence in the other fire also indicated that circular hatches in the main deck were covered with the same patterned carpet, making the location hard to distinguish. While regulations do not require additional marking, there were no additional markings on the deck in the vicinity of the hatches to allow passengers, crews, and potential emergency responders to rapidly identify the location of the hatches. Hazard tape or other floor marking tapes are recommended to clearly delineate the location of the hatch.

Figure 3: Escape hatch (yellow arrow).
